Corporation of the City of London

Environmental Assessment Report **Springbank Dam Rehabilitation**

December 2003

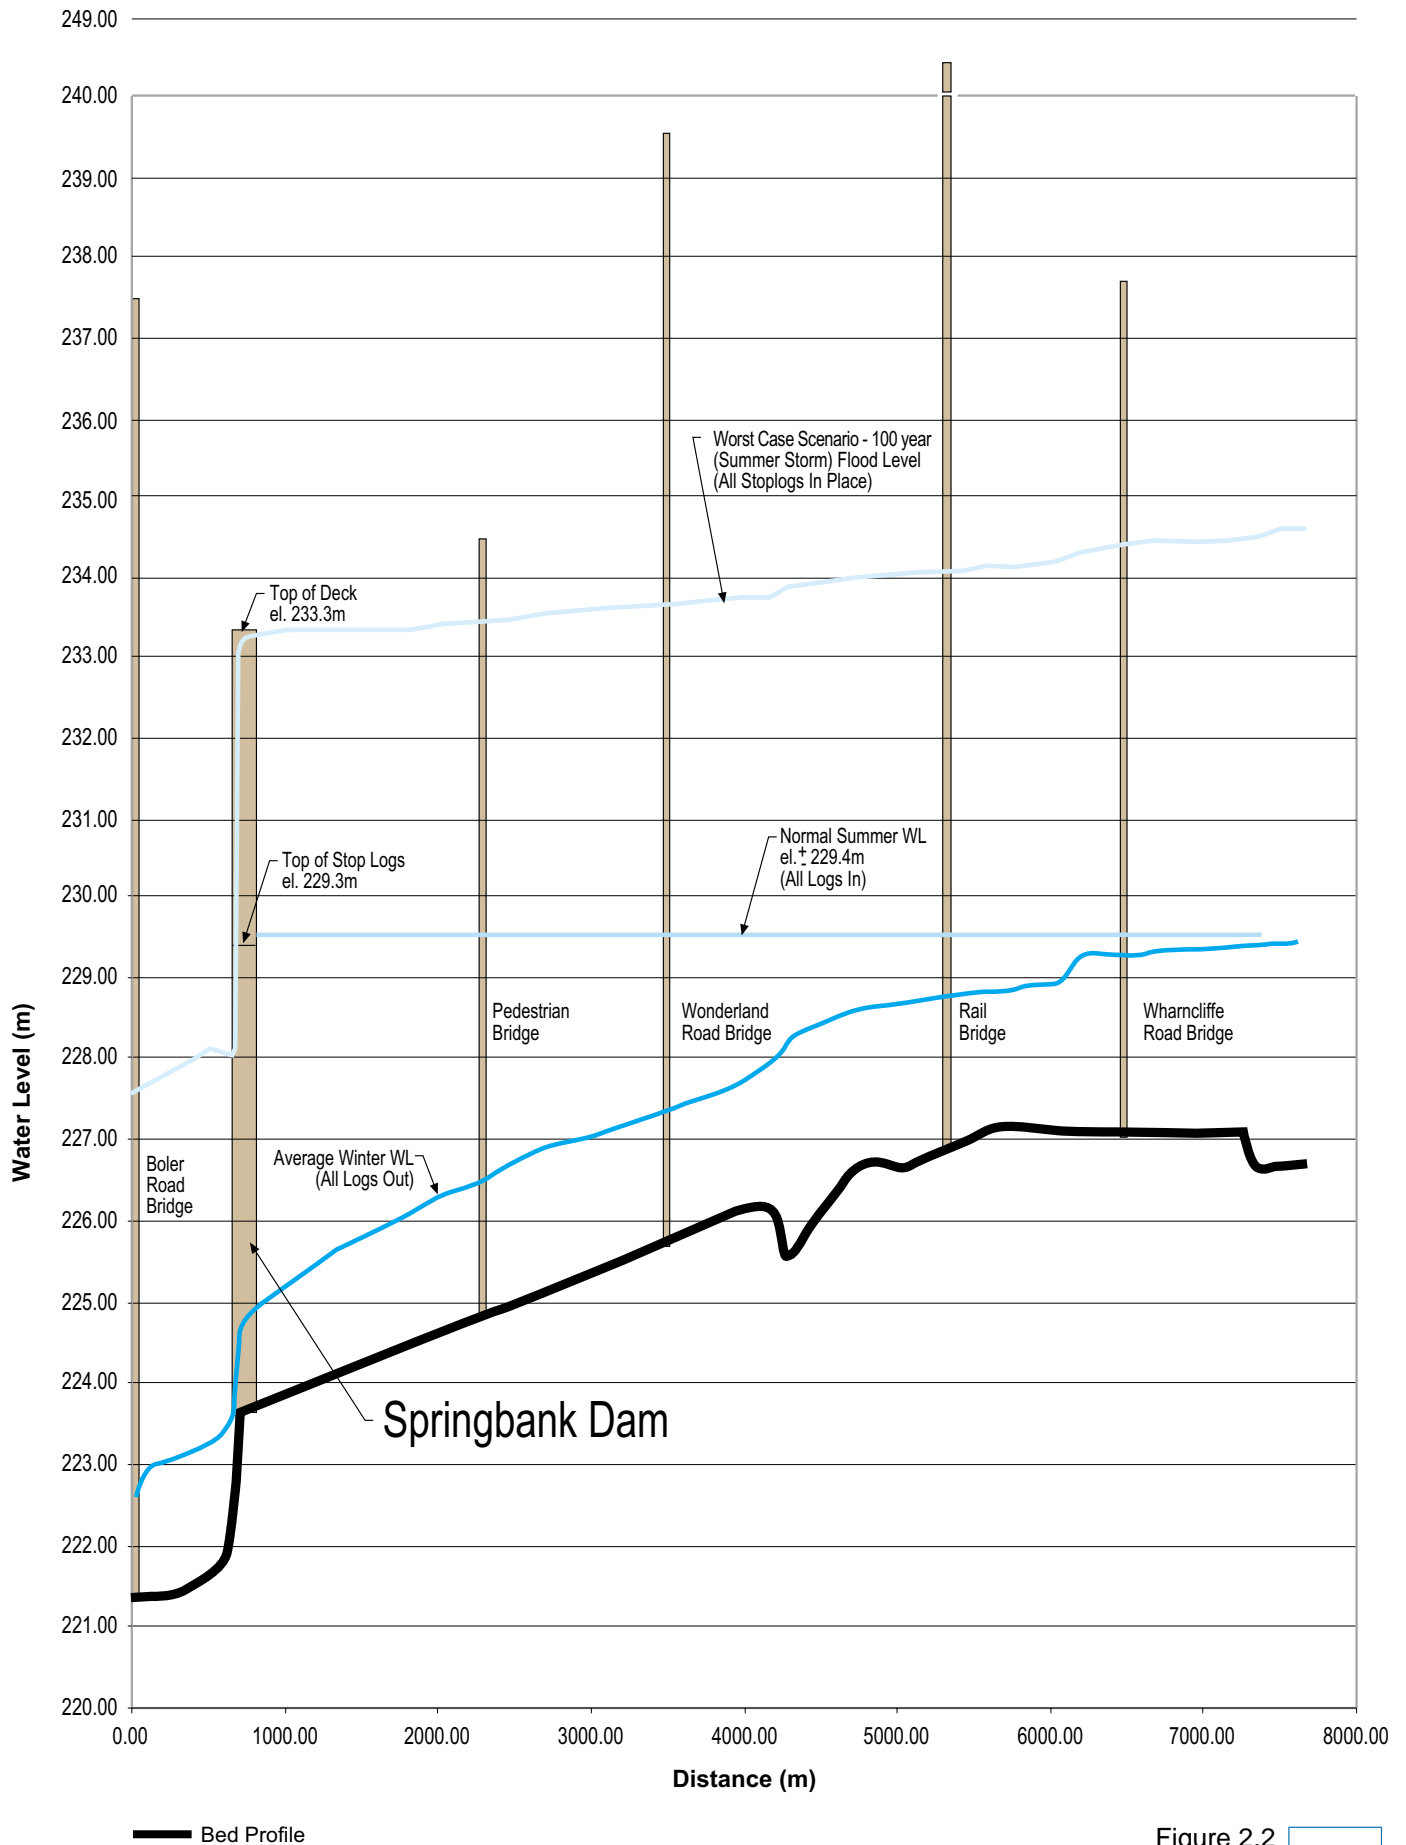
Figure 2.2
 Corporation of the City of London
 Springbank Dam Rehabilitation Class EA
Longitudinal Profile of Thames River Through Study Area

Figure 2.2 depicts a longitudinal profile of the 7.3-km long Thames River study reach through the study area based on the results of HEC-2 computer modeling (Acres, 2002). The figure shows the various water surface profiles along the waterway for the following scenarios:

- Normal summer regulated water level with all stop logs installed in the dam and the vertical lift gate closed.
